LAUREL HILL HOUSE

Historic Structure Report and Treatment Options

V. DRAWINGS

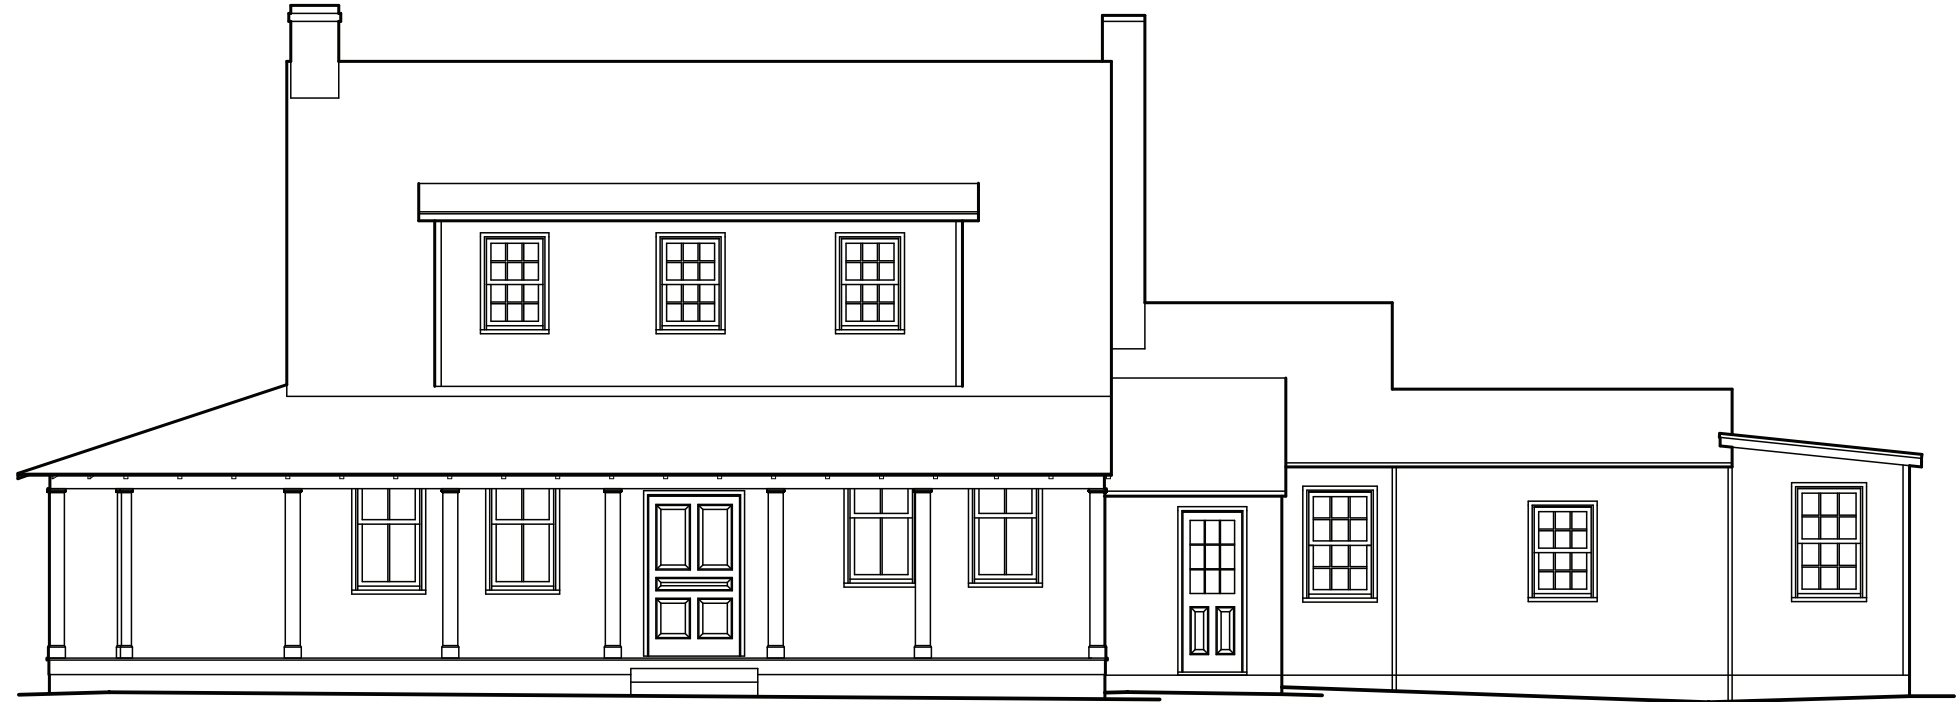
SOUTH ELEVATION
SCALE: 1/8" = 1'-0"

Note: Screen door in front of entrance door not shown for clarity.

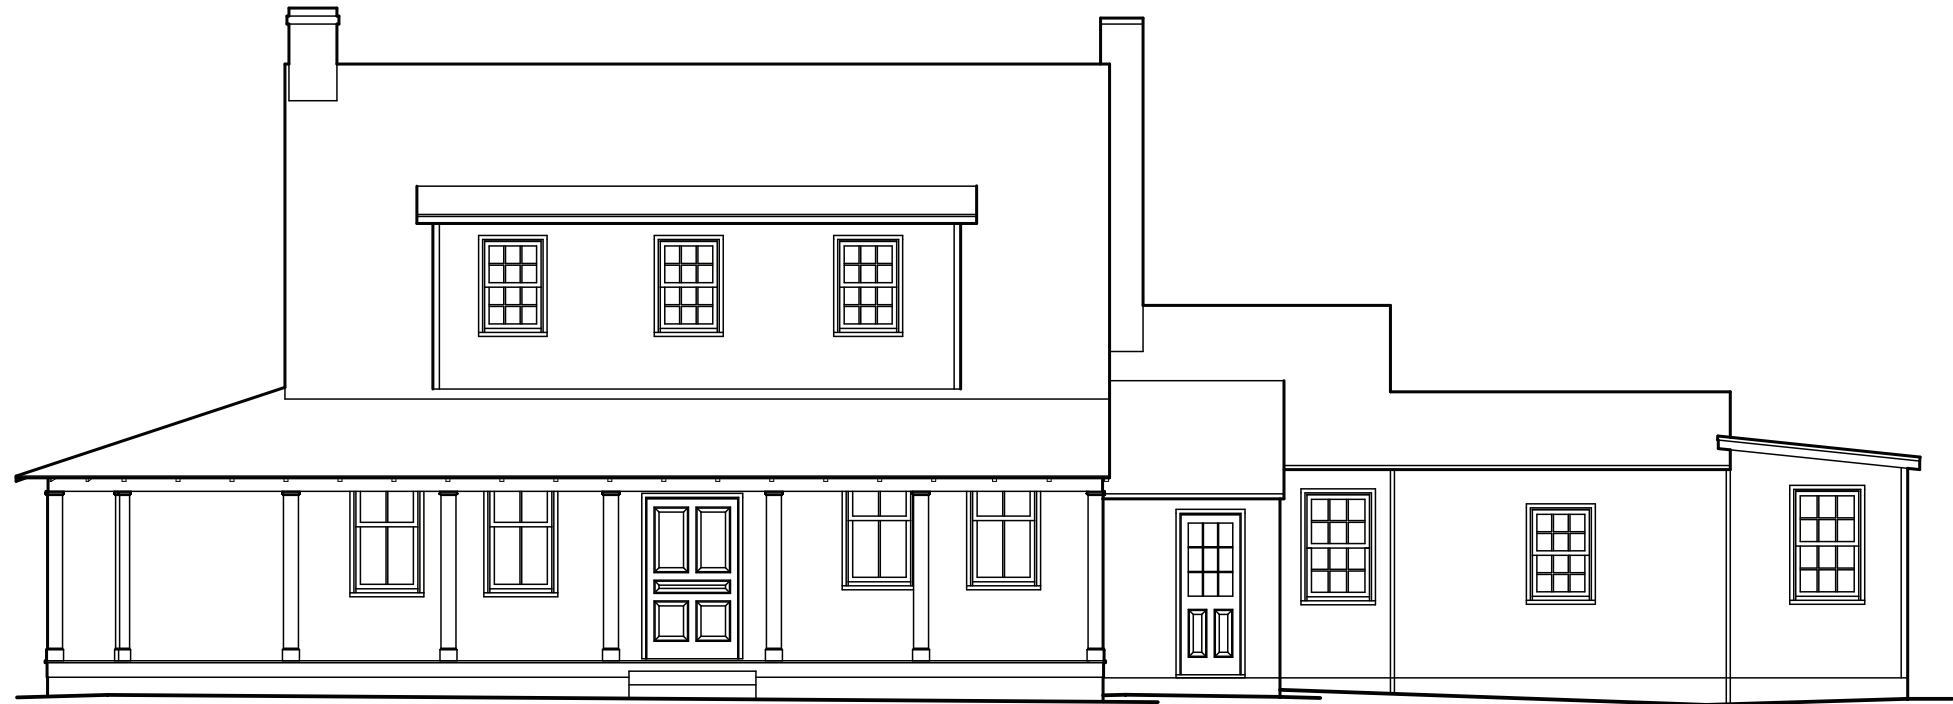
1 SOUTH ELEVATION - OPTION 2
SCALE: 1/8" = 1'-0" 0 4' 8' 16'

Option 2: Rehabilitation of house in its current configuration.
